NRL/MR/6180--98-8172

# Full-Scale Submarine Ventilation Doctrine and Tactics Tests

13. ABSTRACT (Maximum 200 words)  A series of manual intervention fire fighting tests was conducted onboard the ex-USS SHADWELL, the Navy's full-scale damage control platform. The test series evaluated the fire fighters response to underway fire scenarios with respect to the overall tenability conditions (heat and smoke buildup) in the boat, particularly to the Control Room. The underway draft ventilation doctrine was also verified. The test program was intended to provide the technical and scientific basis for changes and improvements to the Naval Ships' Technical Manual (NSTM) 555, Volume 2. Tests were conducted in a simulated Auxiliary Machine Room (AMR) and Laundry compartment with Class A (ALPHA) and Class B (BRAVO) fire threats. The value of fresh water 1.9-cm (0.75-in.) hose reel systems for Class A fire fighting was demonstrated and verified, along with the importance of quick response to fires and personal protection. The use of various ventilation alignments to improve tenability conditions throughout the boat was demonstrated to the Fleet personnel during the fire tests. The detailed res

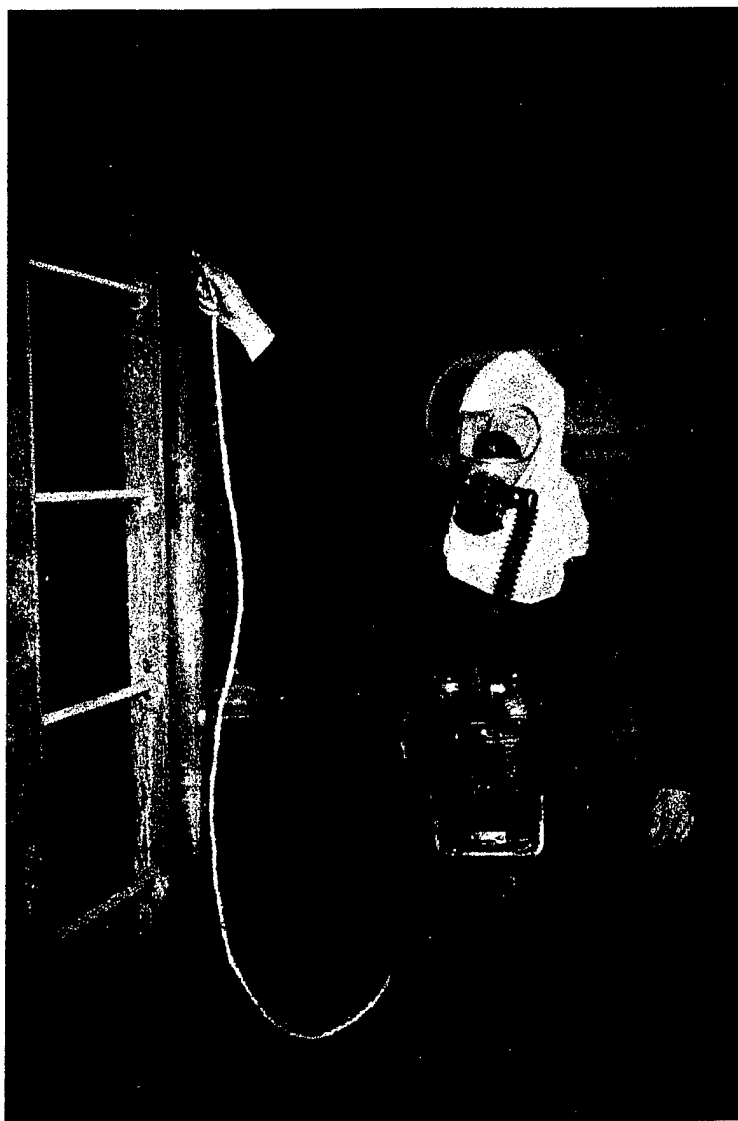
Fig. 3 — Simulated EAB with OBA and rope tether

The use of Emergency Air Breathing (EAB) apparatus is an integral part of submarine damage control doctrine. Piped, low pressure breathing air was not available for these tests. To simulate the use of an EAB, both SCBA's and OBA's were used to simulate EAB's. To simulate the breathing hose connecting the EAB mask to the EAB manifold and the restricted movement of the EAB wearer, an 2.44-m (8-ft) long piece of 0.6-cm (0.25-in.) diameter nylon rope with clips on both ends was used. The entire length of rope was wrapped with duct tape to make the rope less flexible to simulate the stiffness of the rubber hose. The two EAB masks with the 7.62-m (25-ft) long rubber hoses were also made available for use by the test personnel. Figure 3 shows the simulated EAB by the OBA and rope tether.
